Subject: Boeing EQA Report on Slats, Passenger Windows, Fuselage, and Fan Cowl
Fragment - Southwest Airlines 737-700 N772SW Engine Failure and
Decompression Philadelphia, 17 Apr 2018

Equipment Quality Analysis Report

TO: Air Safety Investigation (ASI) **EQA NUMBER:** AS12821
DATE: September 20, 2018
MODEL NUMBER: 737-700
AIRPLANE NUMBER: YA070

SUBJECT: ***Examination of Damaged Components Removed from Southwest Airlines (SWA) Aircraft YA070***

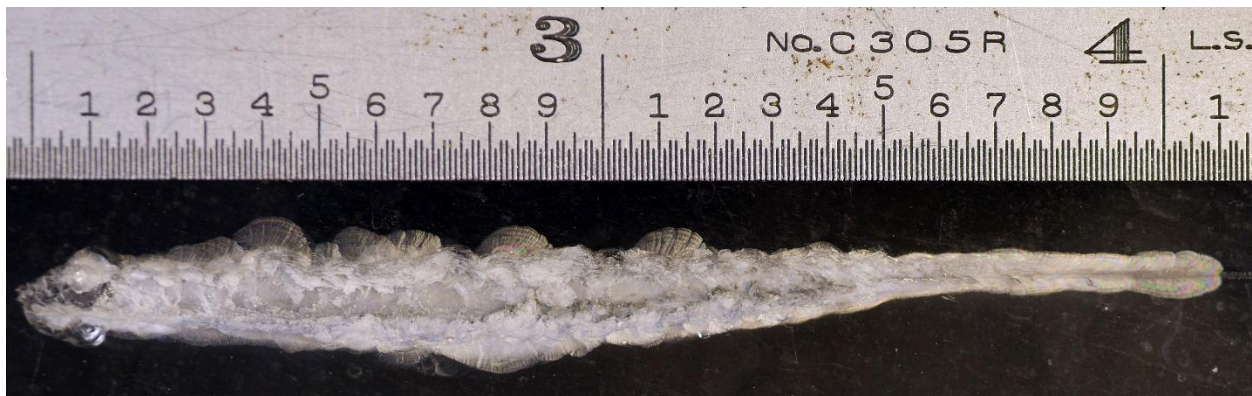
The outer pane of the window assembly had a gouge located near the center that measured approximately 2.2 inches in length and 0.23 inch in width. A magnified view of the gouge is shown in Figure 6.

Figure 6: Gouge in row 24 window

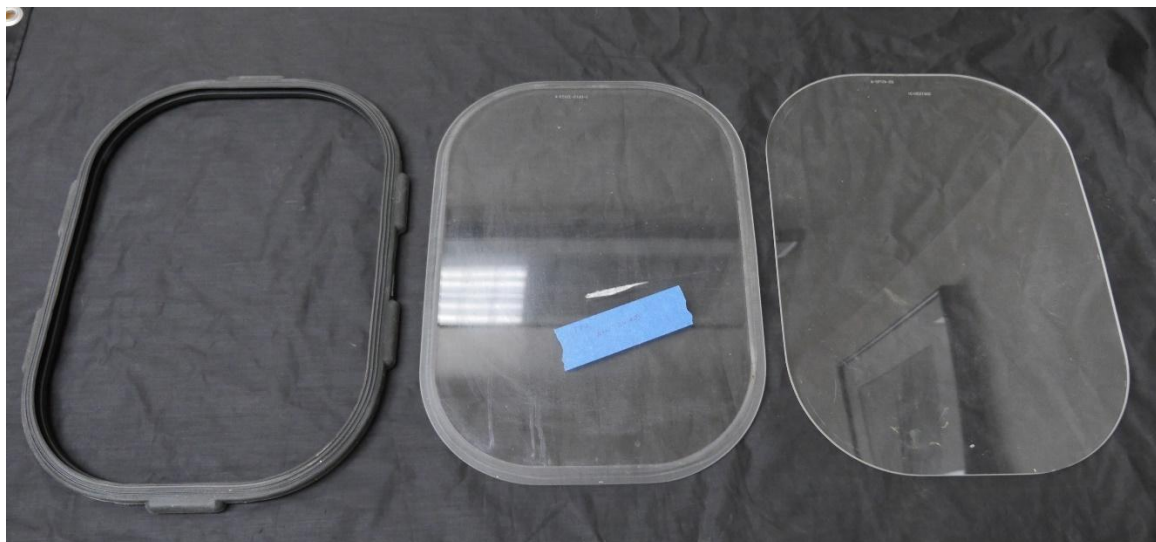
Under direction of the NTSB, the outer pane of the row 24 window was removed from the assembly and sent to BR&T to check for any residual foreign material in the damaged area; see Figure 28.

Figure 7: Row 24 window assembly disassembled

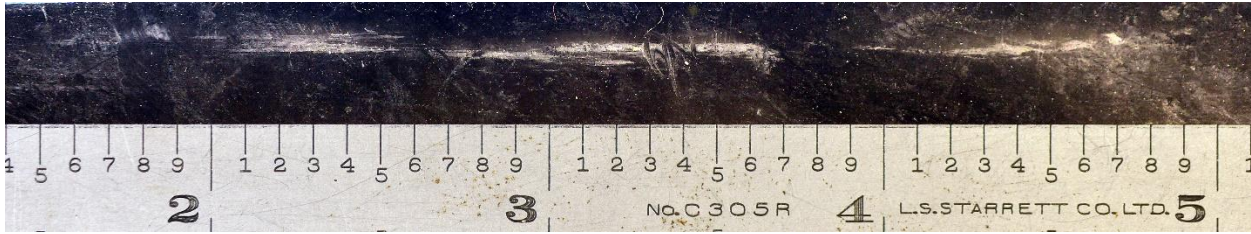
A witness mark was noted on the outer pane of the row 23 window assembly that measured approximately 2.6 inches in length and 0.1 inch in width. The mark appeared to be foreign material that was deposited onto the window pane; see Figure 10.

Figure 10: Witness mark on outer pane of row 23 window

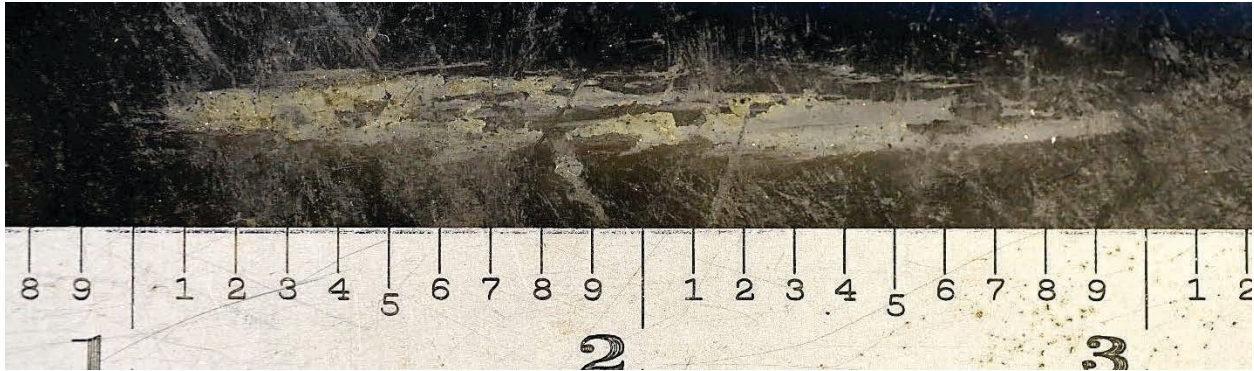
A witness mark was noted on the outer pane of the row 22 window assembly. The most prominent portion of the witness mark measured approximately two inches in length and 0.1 inch in width. The mark appeared to be foreign material that was deposited onto the window pane; see Figure 14.

Figure 14: Witness mark on outer pane of row 22 window

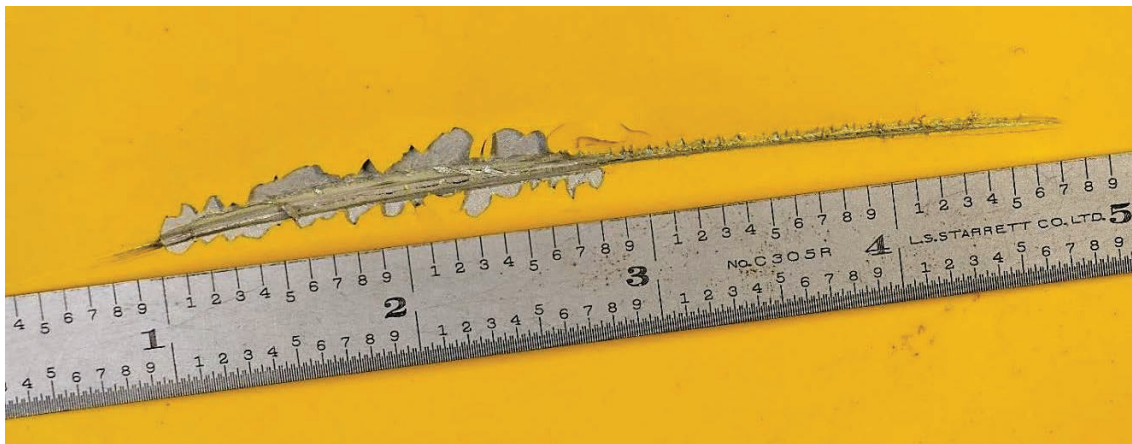
The skin section removed from approximately two feet above the row 24 window had an impact mark approximately 4.7 inches in length and 0.05 inch in width, which penetrated the skin. Per discussion and agreement between all parties present during the examination, the NTSB directed that the row 24 skin section be delivered to BR&T to check for any residual foreign material in the damaged area, with the understanding that destructive analysis may be required. BR&T did not find any residual foreign material in the damaged area of the skin. Only trace amounts of primer were present. See enclosure A for more details.

The skin section was approximately 7.7 inches in length and 2.9 inches in width. It featured a gouge in the approximate center, which measured 4.7 inches in length and 0.05 inch in width at its widest point; see Figure 17.

Figure 17: Gouge in row 24 skin section

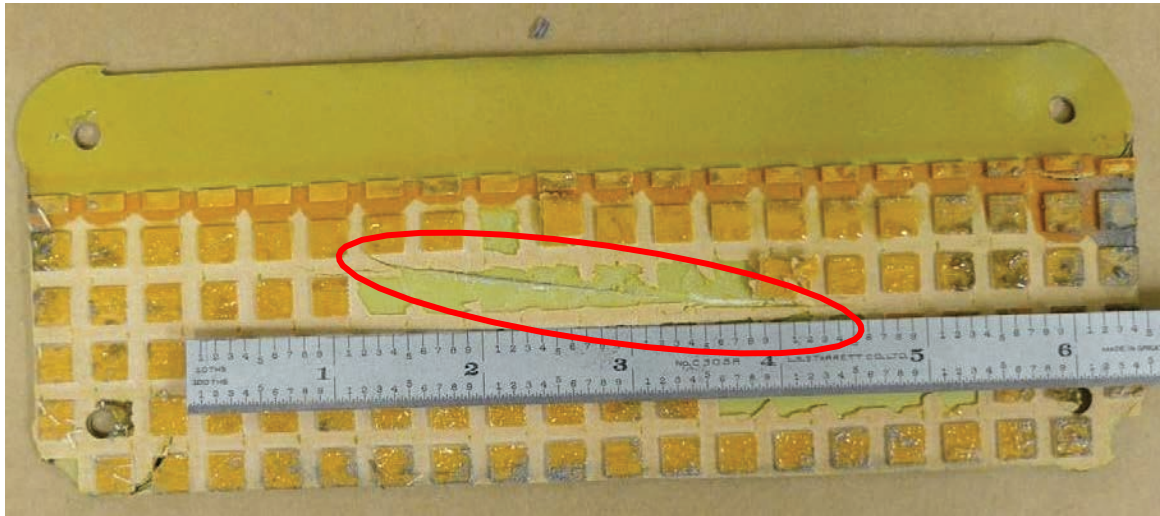
The depth of the gouge was enough to fracture the inner surface of the skin; see Figure 18.

Figure 18: Inner surface of row 24 skin section, showing gouge penetration

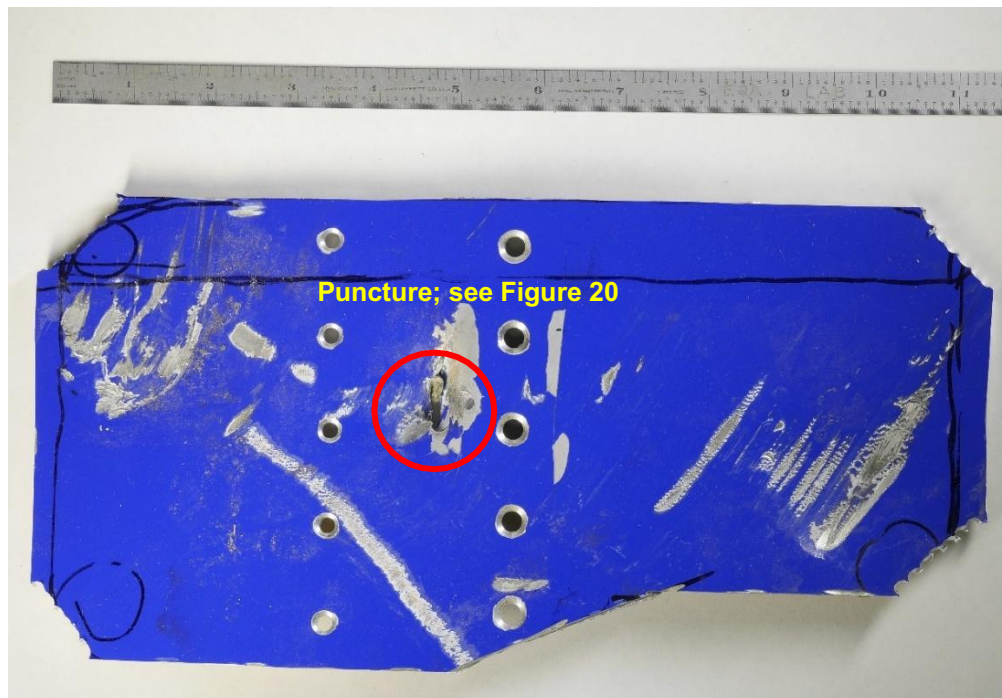
An overview of the section of fuselage skin that was reportedly removed from approximately two feet below the left hand row 14 passenger window is shown in Figure 19. The skin section measured approximately 11.5 inches in length and 5.75 inches in width.

Figure 19: Overview of row 14 skin section

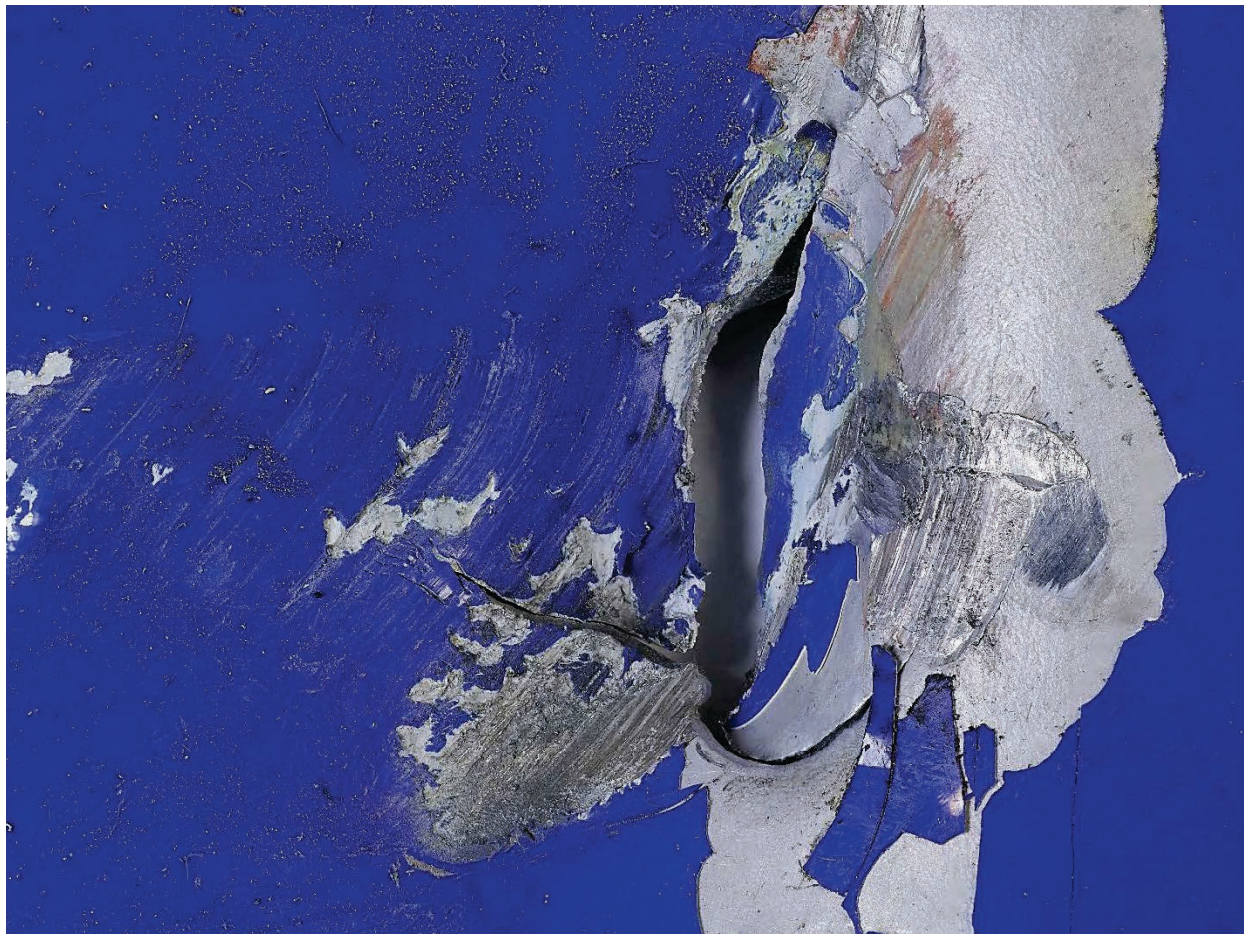
The skin section removed from approximately two feet below the row 14 window had a puncture in between the two rows of removed fasteners. There were also multiple scrapes and scratches in various locations on the exterior surface of the skin section. A grease-like substance was found on the surface of the exterior skin, which had been previously sampled during the initial damage assessment in Philadelphia and was part of the nine samples that were provided to BR&T. See enclosure A for more details.

Multiple scratches were found along the surface of the skin section. A puncture was also observed in approximately the center of the skin section; see Figure 20.

Figure 20: Puncture located in center of row 14 skin section

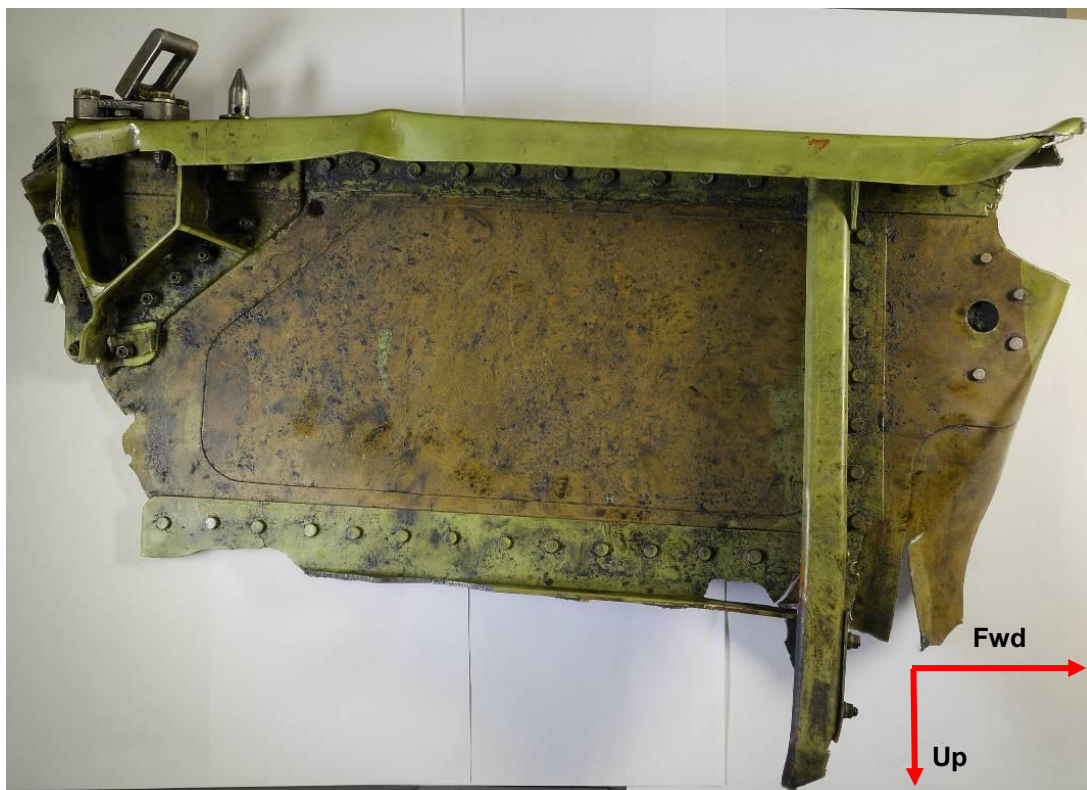
The inboard fan cowl fragment was reportedly recovered from the ground beneath the approximate flight path of the subject aircraft. The fragment measured roughly 22 inches in length and 13 inches in width, and was identified as the lower aft corner of the inboard fan cowl. Overviews of the inboard fan cowl fragment are shown in Figure 22 and Figure 23.

Figure 23: Interior overview of fan cowl fragment

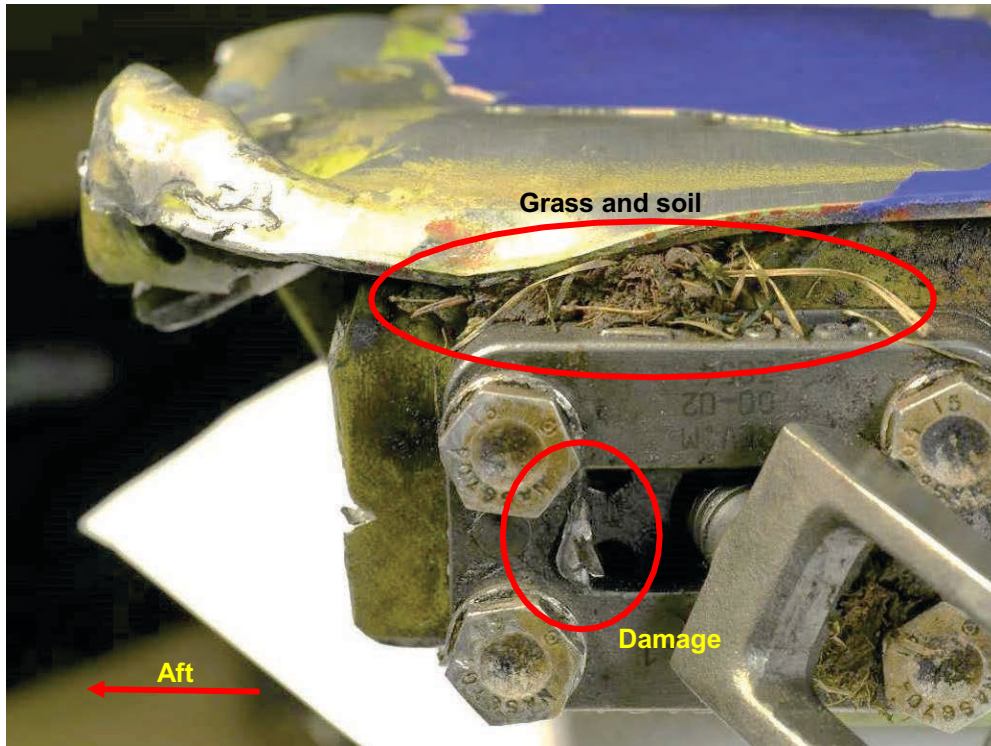
The aft latch keeper, on the lower aft corner of the cowling fragment was found bent forward, with grass and soil remaining on the surface. There was also damage found on the aft edge of the internal portion of the latch keeper base, opposite the direction the bent latch keeper was found. The aft latch keeper is shown in Figure 24.

Figure 24: Aft latch keeper of inboard fan cowl fragment

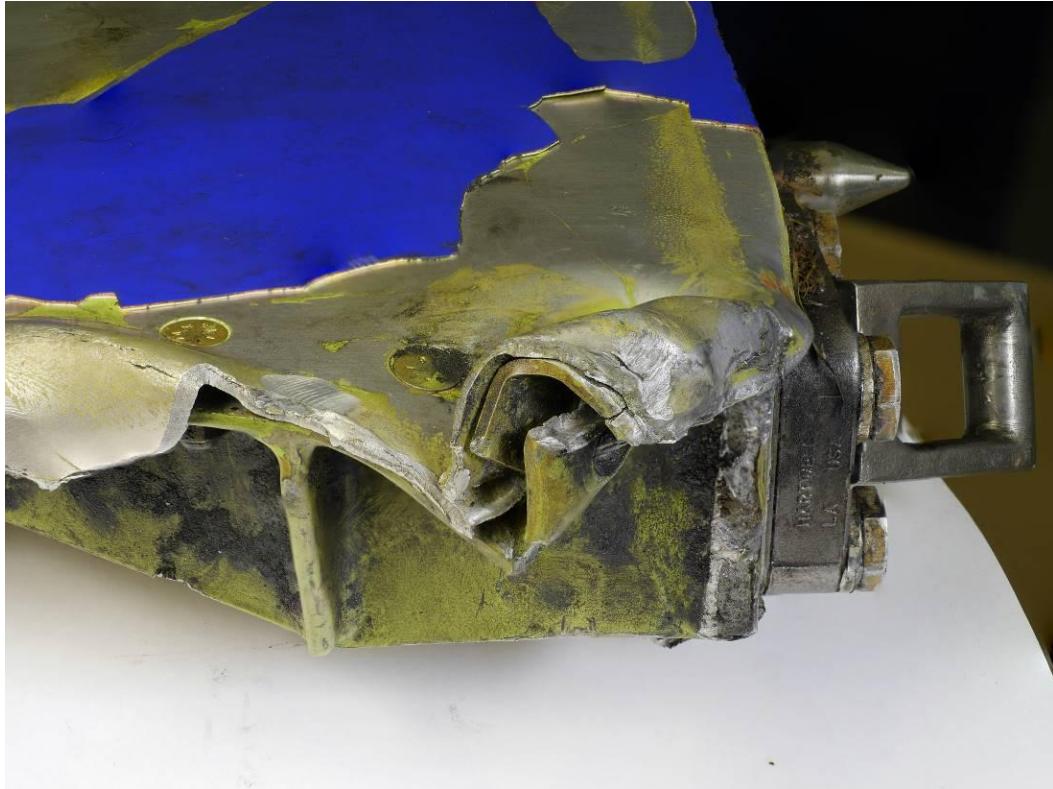
Bent and folded skin, which appeared to be consistent with impact damage was found on the lower aft corner near the latch keeper; see Figure 25.

Figure 25: Lower aft corner of inboard fan cowl fragment

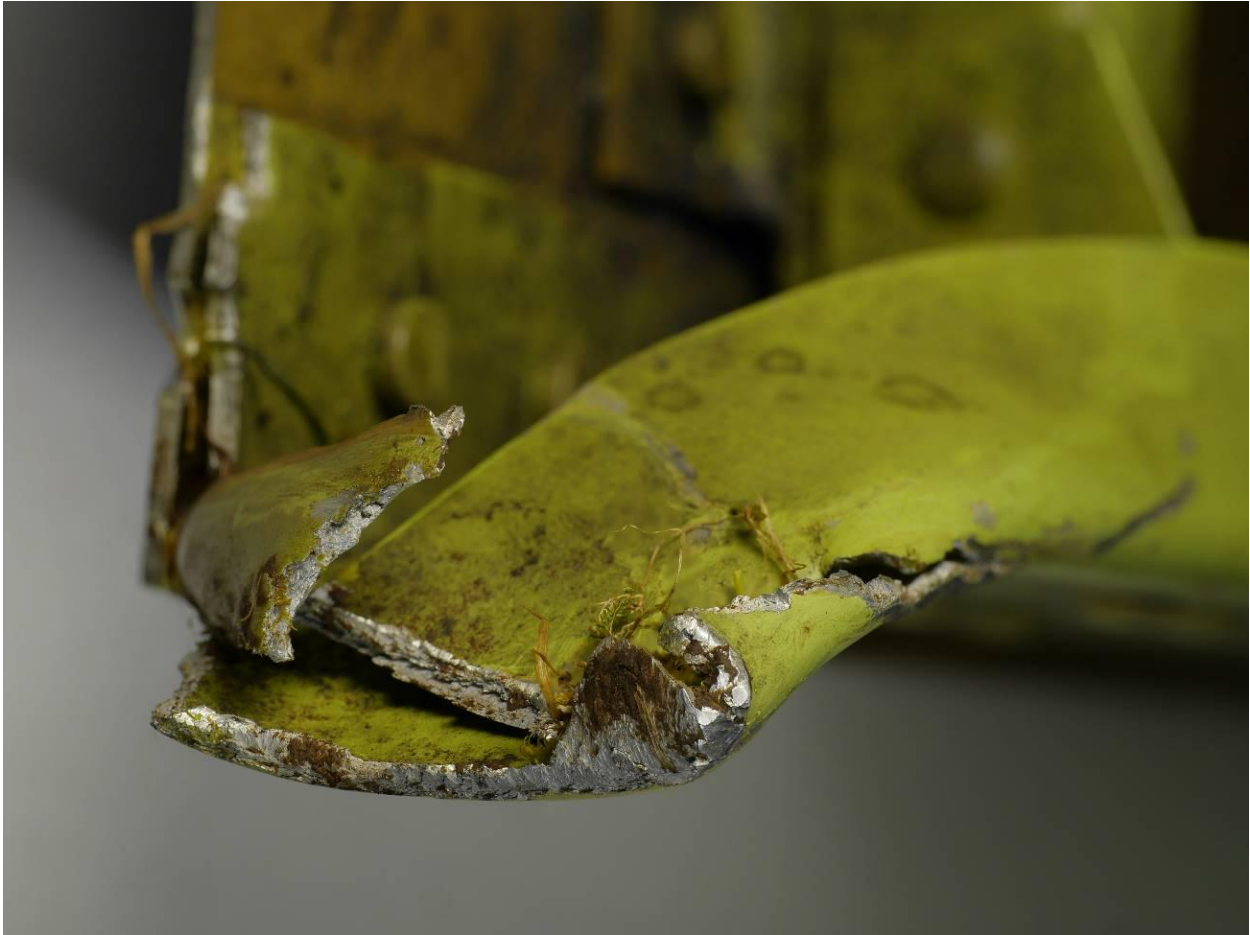
The forward lower corner of the fan cowl fragment was bent and folded, it also had evidence of soil on the surface; see Figure 27.

Figure 27: Forward lower corner of fan cowl fragment

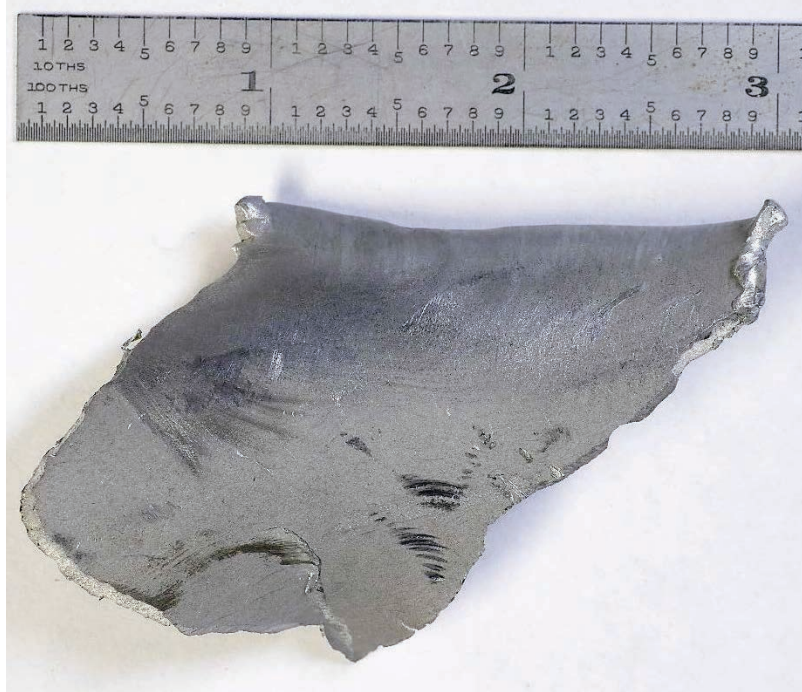
The suspected inlet cowl fragment was reportedly found imbedded in the fixed leading edge of the left wing during the initial damage assessment of the aircraft in Philadelphia. The fragment was removed at the scene and delivered to EQA by the NTSB on May 20, 2018. The fragment was approximately three inches in length and two inches in width; see Figure 29.

Figure 29: Suspected inlet cowl fragment

BR&T used SEM and EDX analysis to identify the material of the suspected engine inlet cowl fragment that was found embedded in the skin of the left wing, aft of the number two slat. The analysis suggests that the fragment was a 2000 series aluminum alloy.

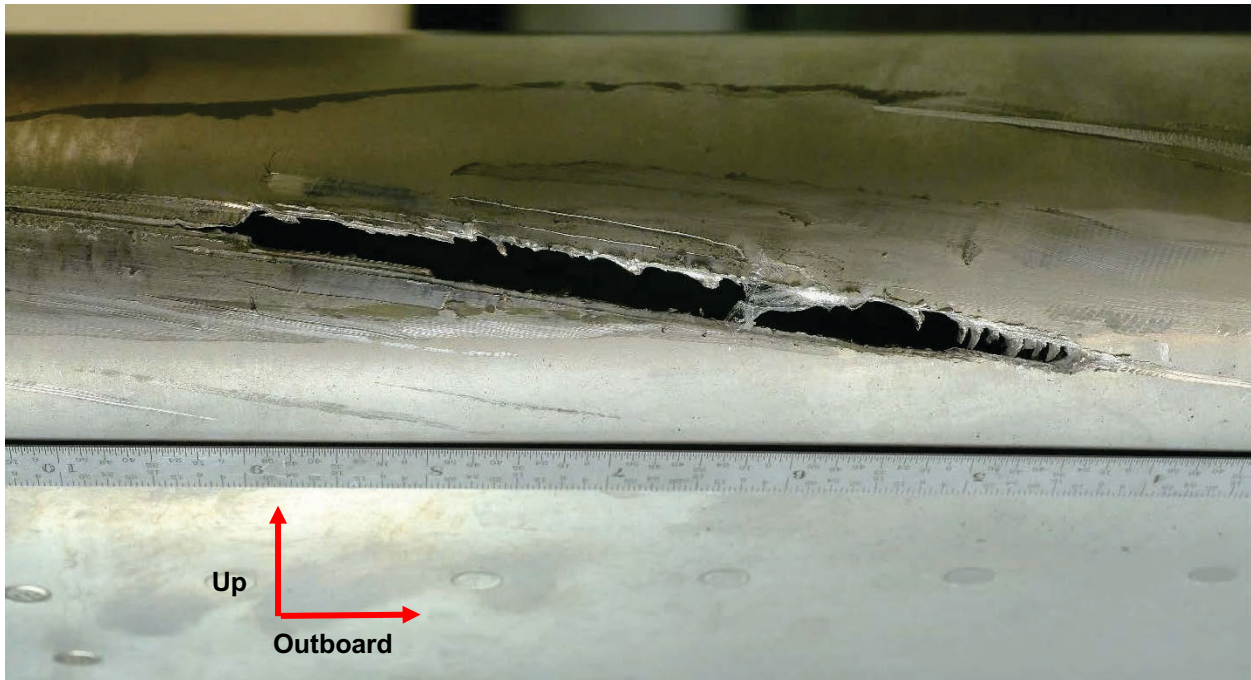
There was evidence of material scrapping along the leading edge as well as above and below it. A gouge approximately five inches in length and a 0.25 inch in width was found between 18 and 23 inches away from the outboard edge; see Figure 32.

Figure 32: Gouge in the leading edge of slat No. 1, approximately between 18 and 23 inches from the outboard edge

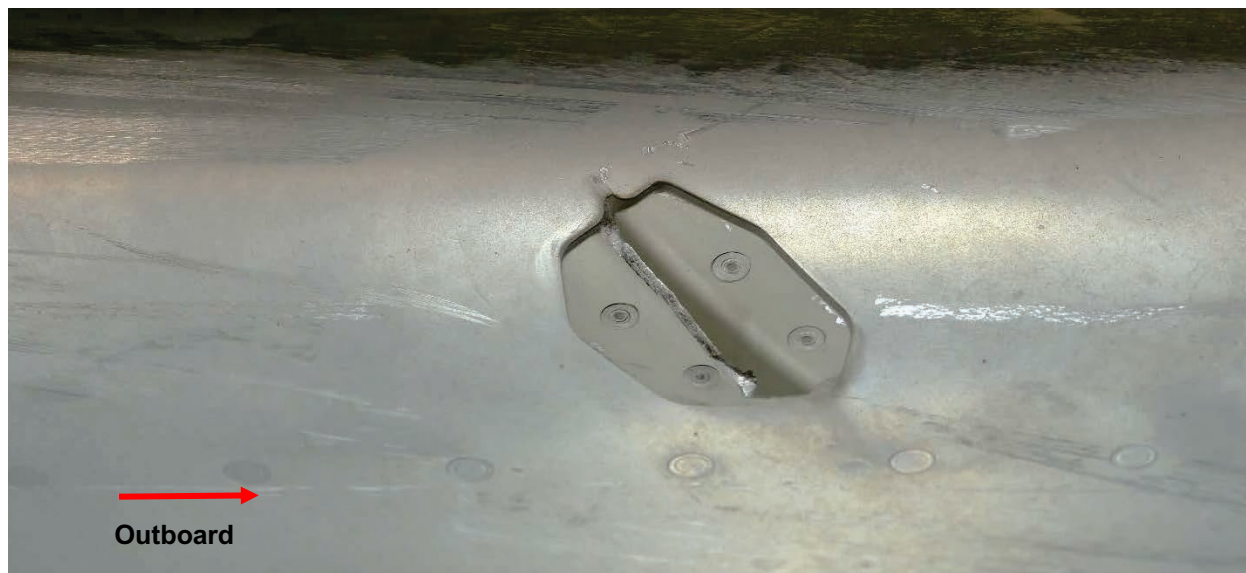
The base of the vortex generator, located approximately 47.5 inches from the outboard edge, remained attached to the lower surface of slat No. 1; see Figure 33. The fin portion of the vortex generator was fractured and missing and the fracture surface was bent towards the outboard direction.

Figure 33: Vortex generator on the lower surface of slat No. 1, approximately 47.5 inches from the outboard edge
Slat No. 2

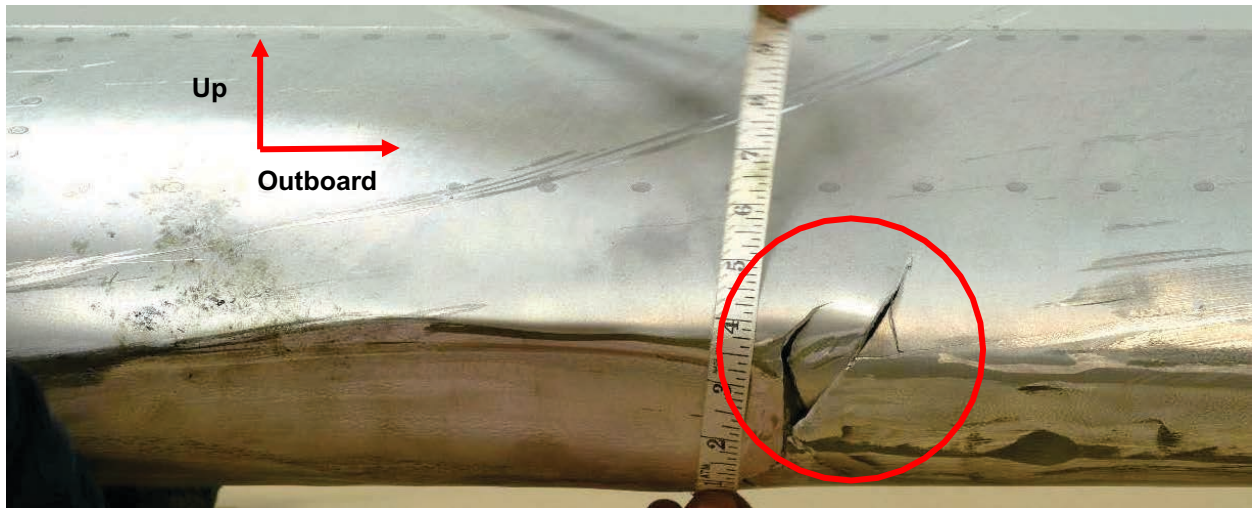
There was evidence of material scrapping along the leading edge as well as above it and below it. The leading edge was semi-flattened and dented in the following locations (measurements in inches from the outboard edge): 37-67 inches, 74-90 inches, 92-97

inches, and 101-121 inches. Approximately 77 inches from the outboard edge, a vertical fracture approximately five inches in length, was present in the dented area of the leading edge; see Figure 36.

Figure 36: Vertical fracture approximately 77 inches from the outboard edge of slat No. 2

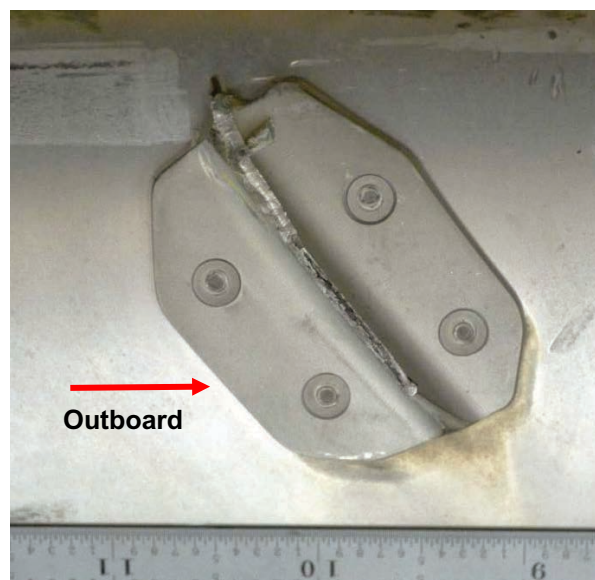
The base of the vortex generator, located approximately 21 inches from the outboard edge, remained attached to the lower surface of slat No. 2, with the fin section fractured and missing. The fracture surface of the vortex generator was bent toward the outboard edge; see Figure 37.

Figure 37: Vortex generator, approximately 21 inches from outboard edge on the lower surface of slat No. 2

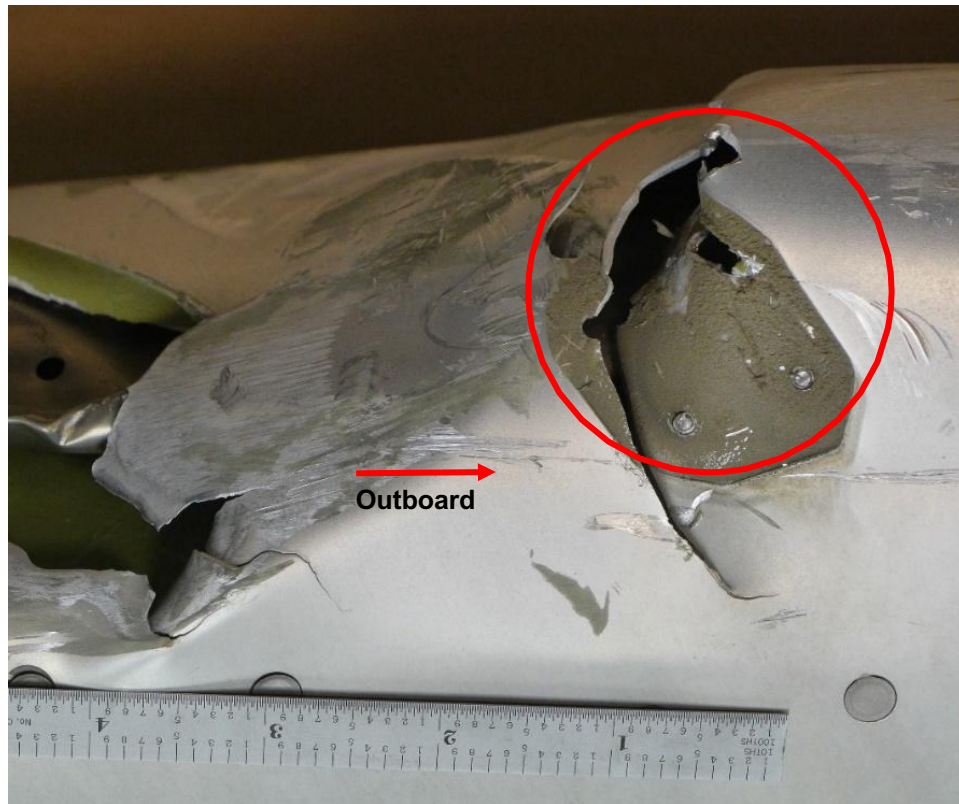
The vortex generator, located approximately 101 inches from the outboard edge on the lower surface, was completely sheared off and missing; see Figure 38.

Figure 38: Approximately 101 inches from the outboard edge, where the vortex generator would have been located on the lower surface of slat No. 2

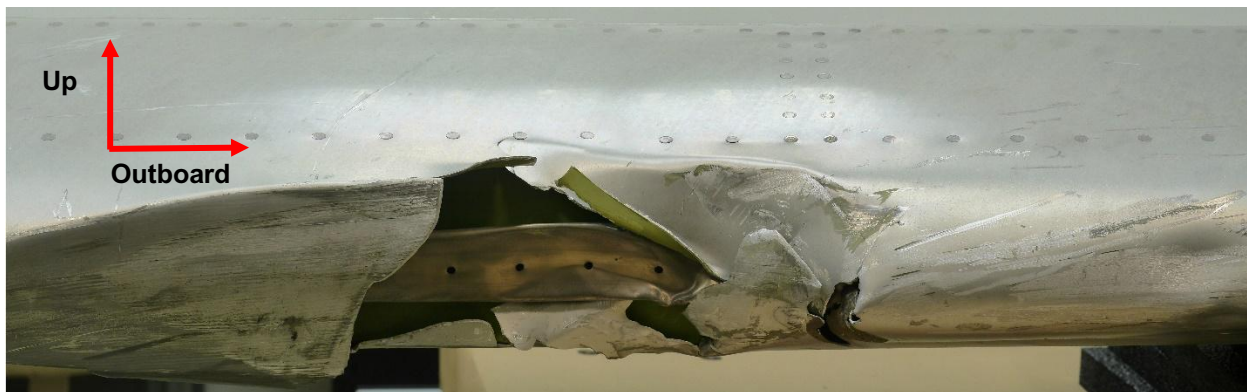
An area of leading edge located approximately from 101 to 117 inches from the outboard edge was fractured with skin material missing. The anti-ice system tubing was also exposed and crushed in the same area; see Figure 39.

Figure 39: Area of leading edge with missing skin material on slat No. 2

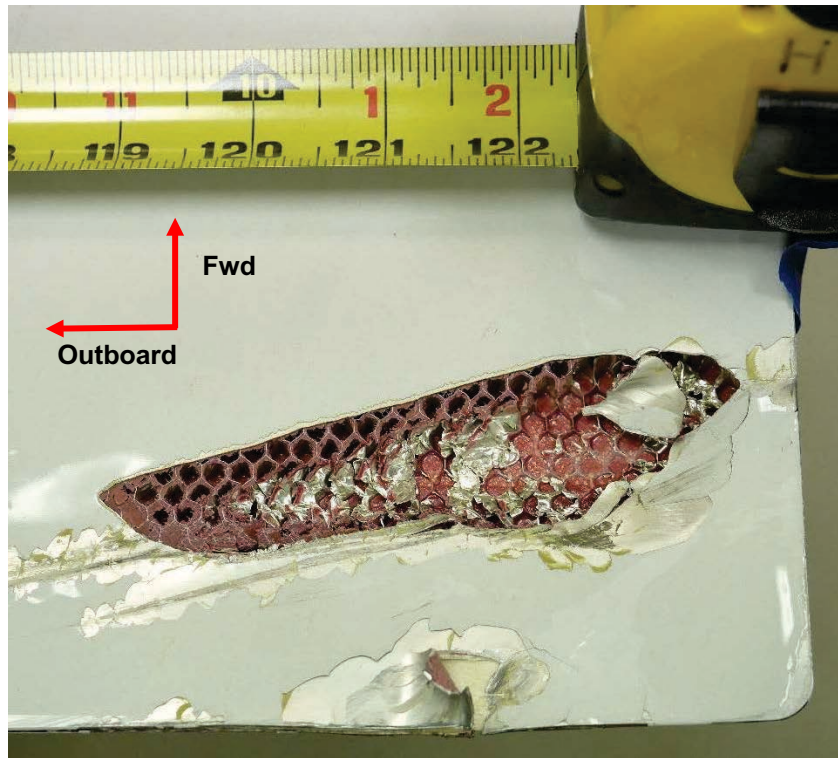
At approximately 121 inches from the outboard edge, on the upper surface, the trailing edge was damaged as well as an area of composite material approximately three inches forward of the trailing edge; see Figure 40.

Figure 40: Upper surface trailing edge damage of slat No. 2

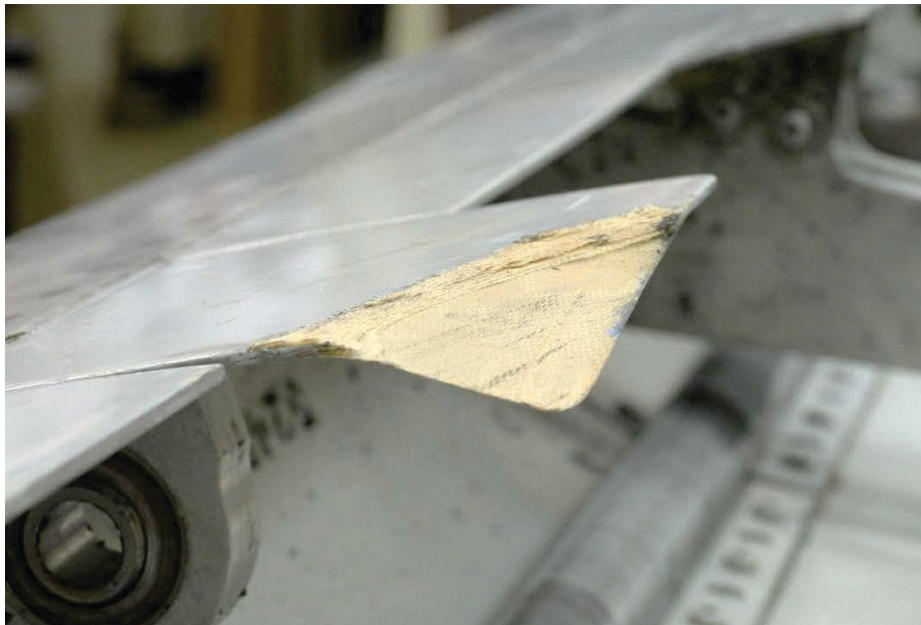
At approximately 103 inches from the outboard edge, on the lower surface trailing edge, a non-metallic panel, which covered a hinge point was damaged; Figure 41.

Figure 41: Lower surface trailing edge damage of slat No. 2

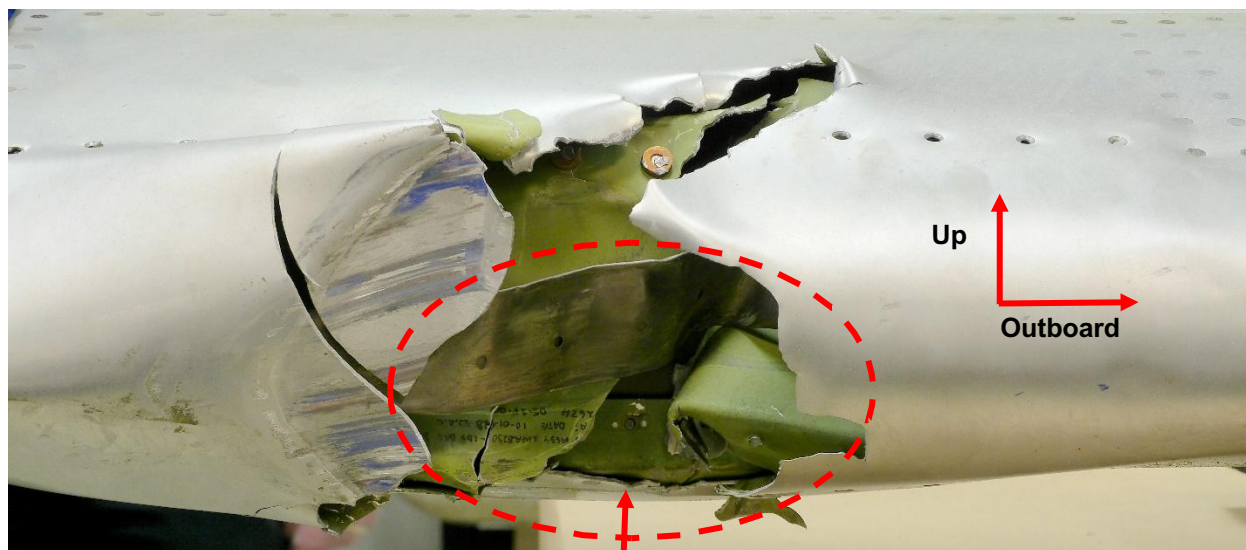
There was evidence of material scrapping along the leading edge as well as above and below it. An area of leading edge located approximately 101 to 112 inches from the outboard edge, was fractured with skin material missing. The anti-ice tubing was also crushed in the same area; see Figure 44. During the initial examination of the aircraft after the incident, it was reported that a metal fragment was removed from this area, and packaged in the same box as the passenger windows. The metal fragment edges appeared to correspond with the fractured skin in the slat, see Figure 45. Under direction of the NTSB, the metal fragment was sent to BR&T for material analysis.

Figure 44: Fracture in slat No. 3 leading edge skin, approximately 101 to 112 inches from the outboard edge

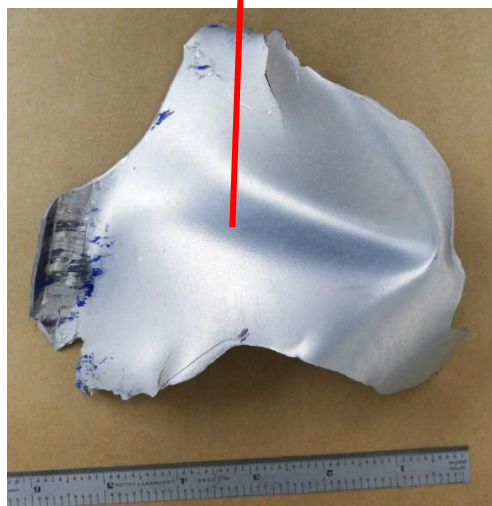
Figure 45: Slat No. 3 skin fragment

BR&T used SEM and EDX analysis to identify both of the metal fragments associated with slat No. 3. The analysis showed that the large fragment most closely matches 7000 series aluminum, and the smaller fragment aluminum alloy could not be identified. See enclosure A for more details.

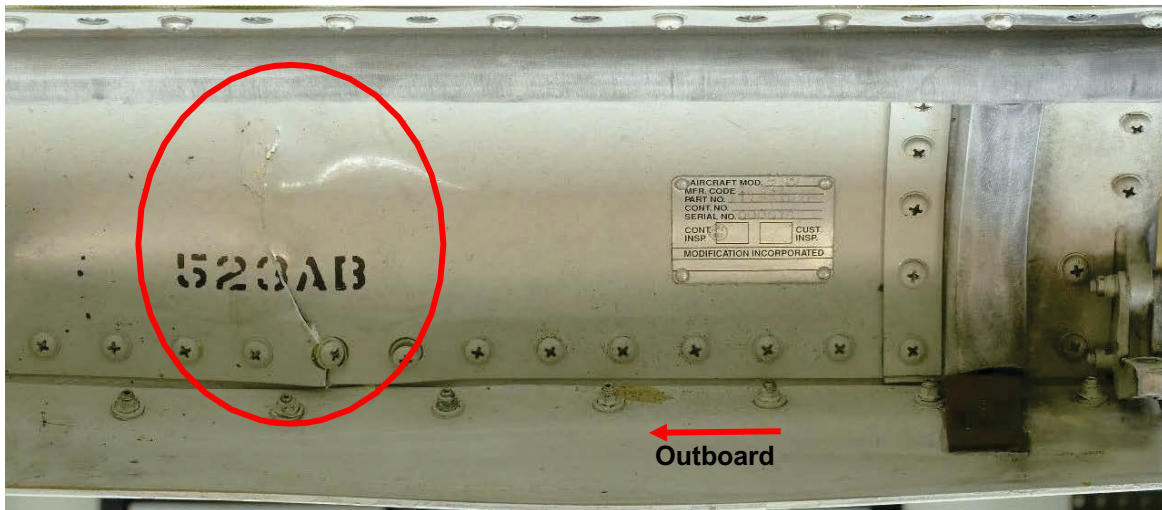
The damage located approximately 101 to 112 inches from the outboard edge was also evident on the trailing side of the slat; Figure 46.

Figure 46: Slat No. 3 trailing side damage

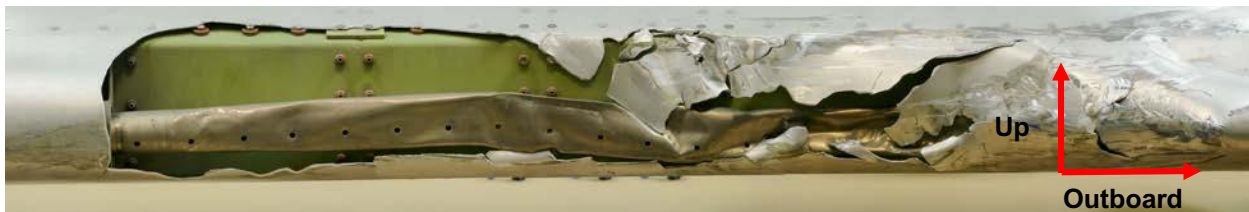
A second area of damage to the leading edge, located approximately 38 to 72 inches from the outboard edge, was fractured. It measured about 34 inches in length and seven inches in width. The anti-ice tubing was also crushed in the area; see; Figure 47.

Figure 47: Leading edge damage on slat No. 3

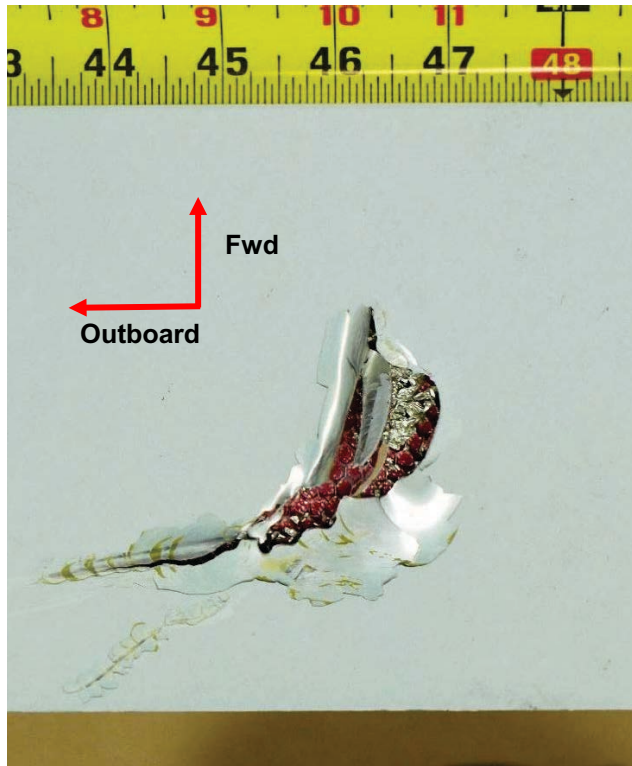
Damage was found on the upper composite surface approximately 46 inches from the outboard edge; see Figure 48.

Figure 48: Upper surface damage on slat No. 3

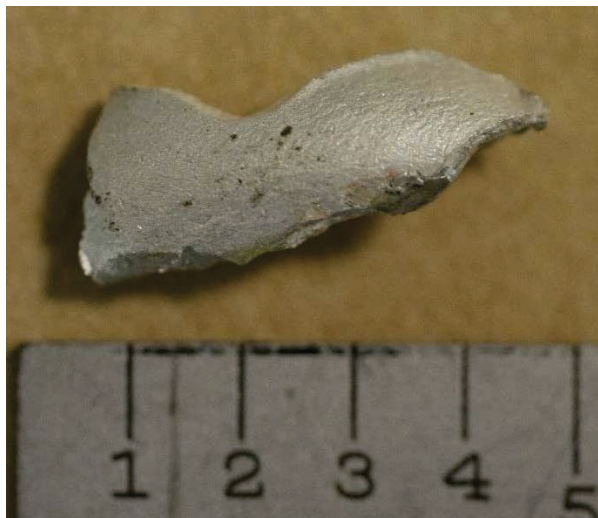
A metal fragment approximately a 0.5 inch in length and a 0.25 inch in width, was found inside the leading edge about 101 inches from the outboard side; see Figure 49. Under direction of the NTSB, the fragment was sent to BR&T for material analysis.

Figure 49: Metal fragment found inside the leading edge of slat No. 3

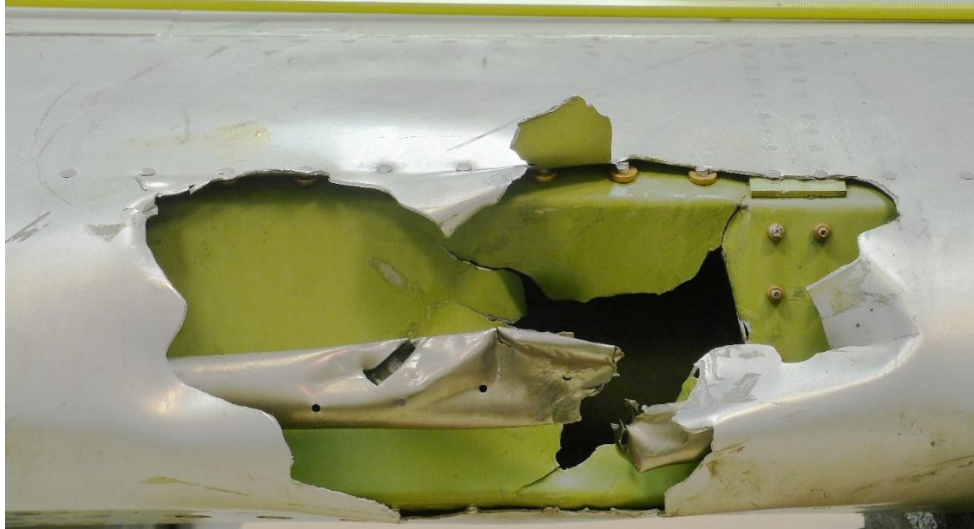
An area of leading edge located approximately between 94 and 109 inches from the outboard edge, was fractured with material missing creating a void, measuring about 14 inches in length and 9 inches in width. The anti-ice tubing in the area was crushed and severed. The forward edge of the nose beam was also punctured in the area behind the anti-ice tubing measuring about 5 inches in length and 5.5 inches in width.

Figure 52: Fracture in slat No. 4 skin and structure

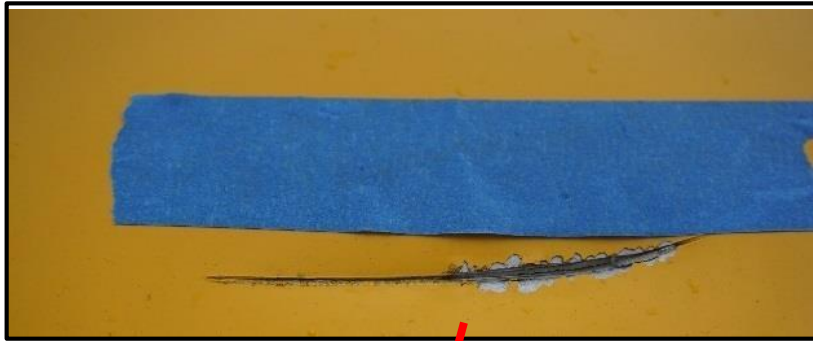
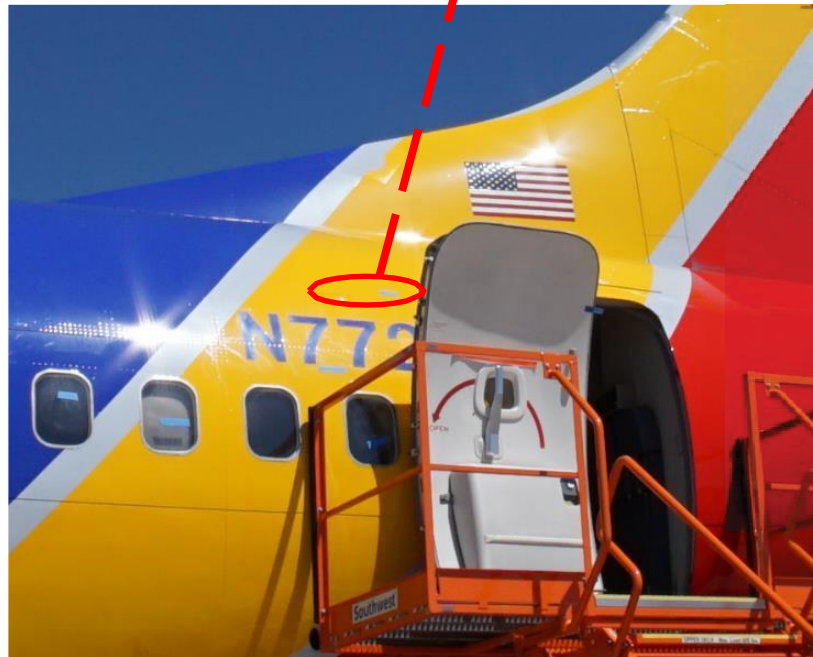
SEM Imaging – looking for metallic deposit on **Exterior Skin Rear #1** (Single Represented Image)

No Metallic fragments were found in this aluminum skin sample – only traces of Carbon, Oxygen, and Silicon

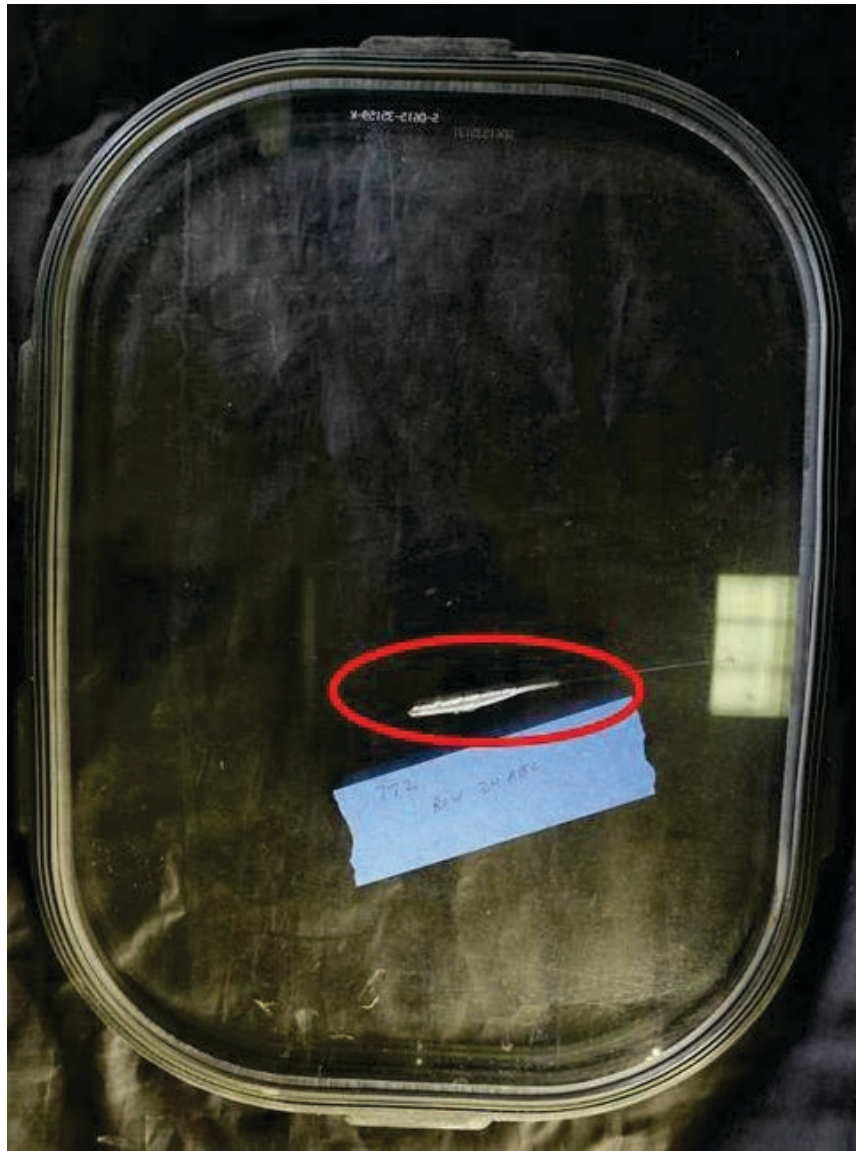
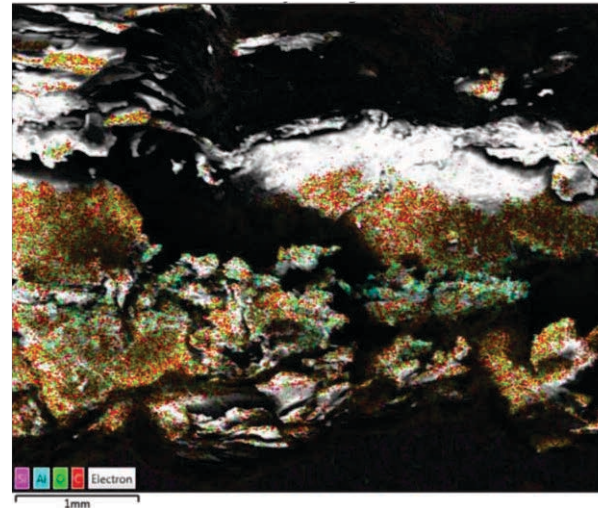
SEM Imaging – looking for metallic deposit in **Window Pane Covering #1** (Single Represented Image)

Trace amounts of Aluminum fragments were found in this sample. Also present is Carbon, Oxygen, and small amounts of Silicon

The Aluminum trace fragments most closely match the 7000 Series. An exact match is not possible due to the small particle size.
